"Regettering" Gu-74b tubes in the Alpha 91 β Amplifier

This technique should also apply to the Alpha 99 and possibly Acom amplifiers as well

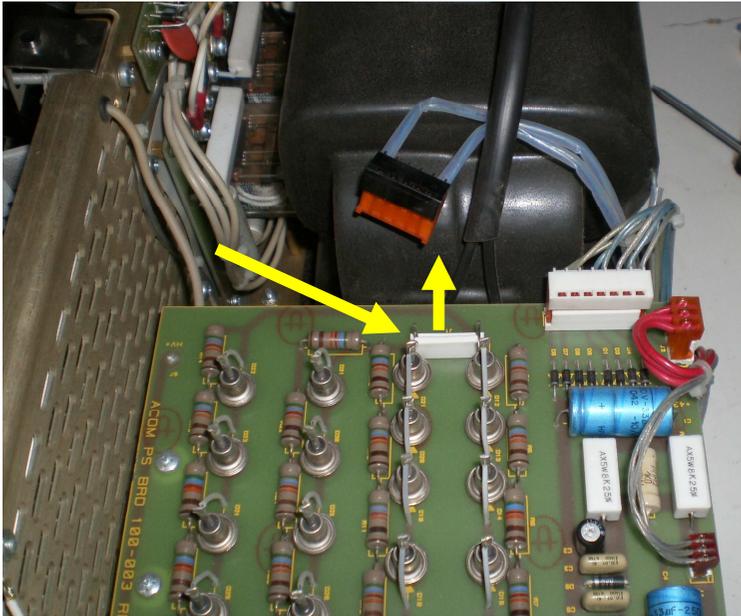
Figure 1. Pull B+ from Rectifier Board

Pull the B+ plug out of the top power supply board (it is a big connector, but only two pins are connected).

Plug in the screen voltage spade tab to the filter capacitor board using long nose pliers. Plug in the B+ connector from the power transformer to the rectifier board. Double check that you've firmly connected everything before you install all of the top cover screws.

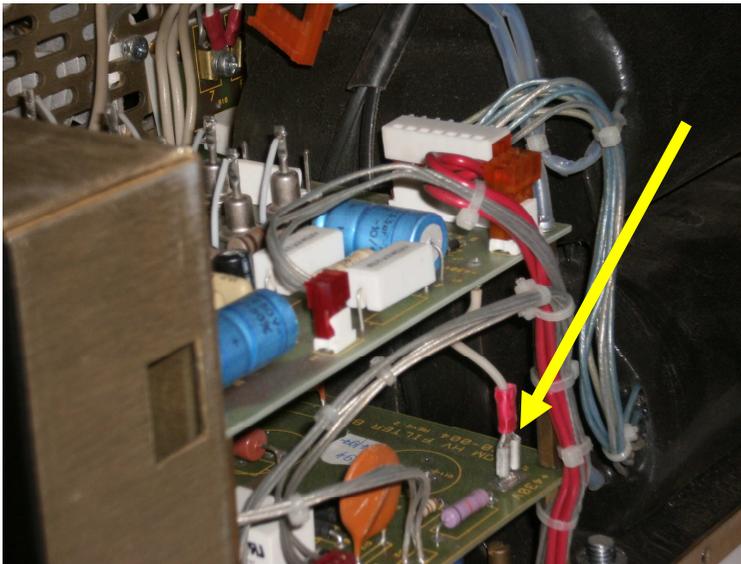
Figure 2. Screen Supply—Connected

Pull the Screen voltage wire (spade connector) out of the lower power supply board (the one with the filter capacitors). You access this from the right-hand side of the amplifier. Long nose pliers are helpful. Bend it out of the way so it doesn't short into anything.

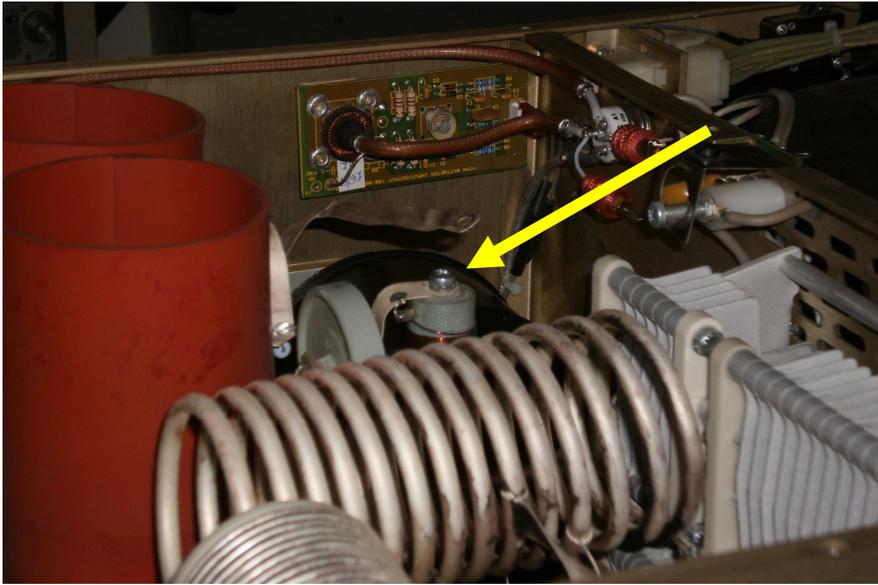
Figure 4. Remove Parasitic Suppressor Strap from Plate Choke

Remove the screw holding the parasitic strap from the plate choke. Remove the existing tubes, red rubber chimneys, and suppressors as one unit. Try to pull the tubes straight up out of their sockets. Work off the chimneys.

After the time has elapsed, unplug AC power and open the amplifier. Replace the parasitic suppressors (caution: the tube bases will be *hot*, even though the blower has been running).

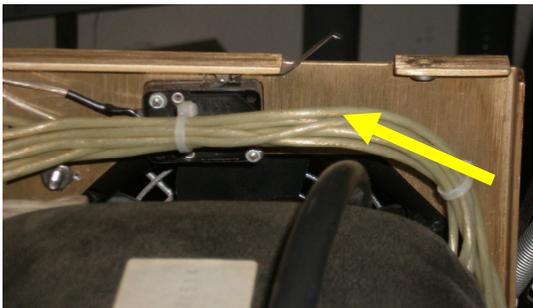
Figure 6. Rear Panel Line Interrupt Switch

Ensure the screen supply spade connector will not touch the top cover. Replace the top cover and install a couple of the machine screws along the rear so the interlock switch is held closed. Note that there is no need to disable the interlock tab in the middle of the amp, as there should be no B+.
